Flight Demonstration of X-33 Vehicle Health Management System Components on the F/A-18 Systems Research Aircraft

*Keith A. Schweikhard, W. Lance Richards and John Theisen
NASA Dryden Flight Research Center
Edwards, California*

FLIGHT DEMONSTRATION OF X-33 VEHICLE HEALTH MANAGEMENT SYSTEM COMPONENTS ON THE F/A-18 SYSTEMS RESEARCH AIRCRAFT

9. SPONSORING/MONITORING AGENCY NAME(S) AND ADDRESS(ES) National Aeronautics and Space Administration Washington, DC 20546-0001			10. SPONSORING/MONITORING AGENCY REPORT NUMBER NASA/TM-2001-209037

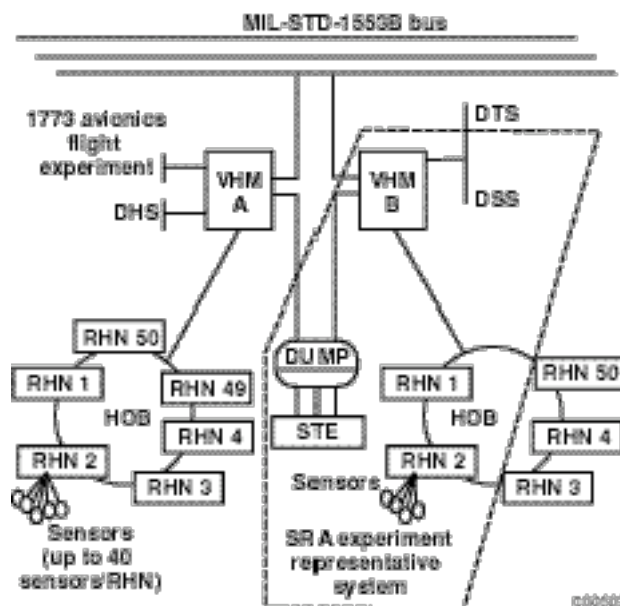
Figure 1. X-33/SRA configuration.

The X-33 VHM architecture (fig. 1) acquires data from a wide variety of sensors and systems. The system monitors and records all data on the vehicle, including all the flight bus data, all vehicle health data (structural, mechanical and system built-in test (BIT) status), and all the flight test instrumentation sensor data. This system interfaces to a NASA Jet Propulsion Laboratory avionics flight experiment that communicates over a MIL-STD-1773 fiber optic interface [2].

The VHM system uses a distributed sensing architecture to collect data from conventional sensors. The data are concentrated using 50 RHNs to gather structural, mechanical and environmental sensor data. Each RHN communicates with the VHM computer over a fiber optic health optical bus (HOB). The VHM computers (1) acquire data from the HOB, (2) monitor and record all MIL-STD-1553B data [3], and (3) gather fiber optic distributed temperature, hydrogen, and strain sensor data from digital signal processors which reside in the VHM computer. Optical sensors are mounted directly on the X-33 propellant tanks, while the driving optics and processing are housed in the VHM computers.

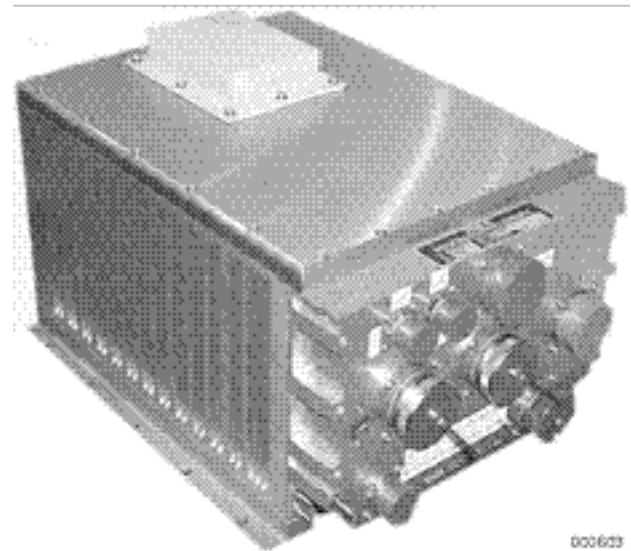
Figure 2. VHM-A/B.

The X-33 vehicle health manager-A (VHM-A) shown in figure 2 is one of two nearly identical versa-module-eurocard (VME)-based computers housed in a modified full air transportation rack chassis used to monitor and record data. VHM-A contains a commercial off-the-shelf or military off-the-shelf standard processor interfaced to a 4.5 gigabyte PC-based hard disk drive storage module and various input/output modules. VHM-A connects to 25 RHNs by means of the fiber optic HOB implementing an FDDI. The distributed fiber optic temperature sensors and MIL-STD-1553B bus monitors interface directly to the VHM-A computer. The VHM-A computer acts as a remote terminal by using a MIL-STD-1553B interface for VHM command and control information. VHM-B is nearly identical to VHM-A; the differences are that the VHM-B line replaceable unit contains the distributed fiber optic strain and hydrogen sensors. The VHM computer also handles telemetry downlink, recorder download, and system diagnostic functions.

The modified chassis design for the VHM computer (fig. 2) resulted in a box that would not fit in a standard avionics rack. As a result the computer was installed vertically on an instrumentation rack located in the gun bay on the SRA. This installation subjected the VHM computer to “off axis” loading for a significant portion of the test program.

VHM computer modifications included incorporation of GEN II fiber optic connectors and a multi-channel single-mode fiber optic connector for the DSS. Software modifications were made to integrate the system onto the SRA. These modifications changed the computer operating commands and time synchronization from a MIL-STD-1553B interface to an analog switch to command the recorder and an RS-422 interface to provide time synchronization. Additional changes included; changing to a single FDDI module for both the RHN network and the recorder download, and the use of solid-state memory replacing the hard disk drive.

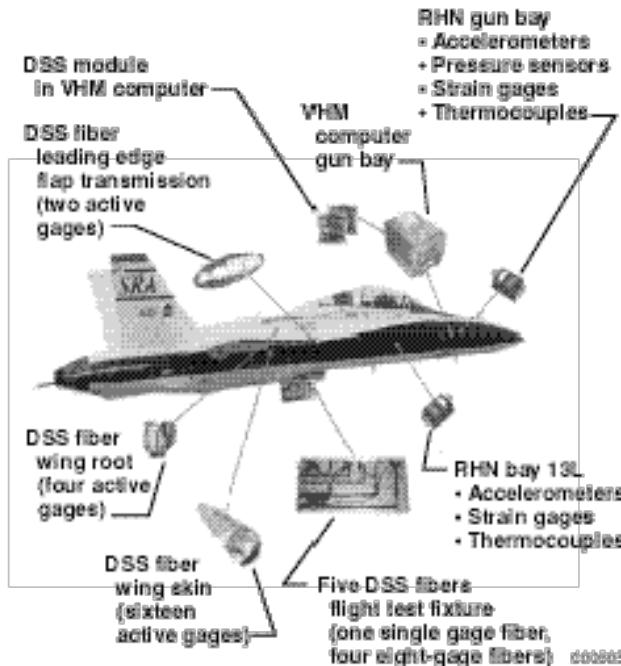
Figure 4. VHM experiment configuration.

High-risk components of the X-33 VHM system were identified for the SRA flight demonstration. These components comprised a representative subset of the overall X-33 VHM system architecture (fig. 1). Slight modifications were made to the X-33 VHM components to either validate technologies that would eventually be fielded in a VHM system or that were necessary to interface into the F/A-18 SRA. A diagram of the SRA experiment configuration is shown in figure 4.

Modifications to the SRA VHM experiment included: a single VHM computer with solid-state memory replacing the disk drive, a single FDDI module, a DSS module, and GEN II optical interconnects. Two RHNs were configured in a half-FDDI ring configuration.

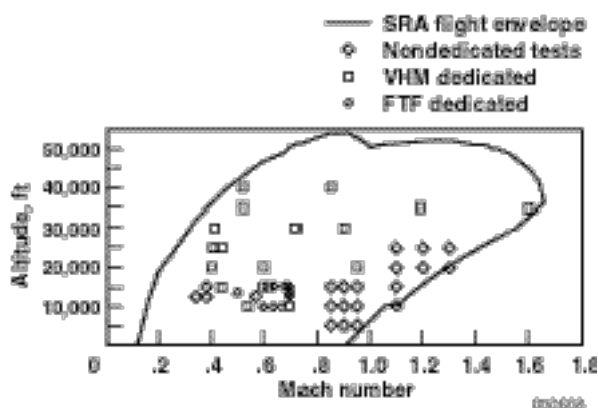
Figure 5. Flight envelope.

The VHM experiment began flying on the SRA at the end of September 1999. Flight tests concluded in early April 2000. The experiment was installed on the aircraft for 53 flights and flew for over 46 hours. These missions covered a large portion of the SRA flight envelope. Figure 5 shows the flight conditions accomplished during the test program. Thirteen of the 53 flights were dedicated to testing the VHM system. Eleven of the thirteen dedicated VHM flights were used to characterize the DSS using the FTF. The remaining two dedicated flights were used to gather RHN data in regions of the aircraft flight envelope not covered during the nondedicated flights. The remaining 40 flights were dedicated to testing other experiments being flown on the aircraft. Data were collected during these 40 missions, but there were no test maneuvers specifically dedicated to the VHM experiment.

Two of the fifteen dedicated flights were used to gather RHN data in regions of the flight envelope that were not reached during nondedicated flight test, nor during FTF flights. Constant speed climbs and descents, and dynamic maneuvers were performed at eighteen flight conditions highlighted in figure 5. The aircraft was dynamically loaded to 6 g and subjected to high pitch- and roll-rate maneuvers during these flights. The aircraft reached altitudes of over 40,000 ft and speeds of Mach 1.6 during these test maneuvers.

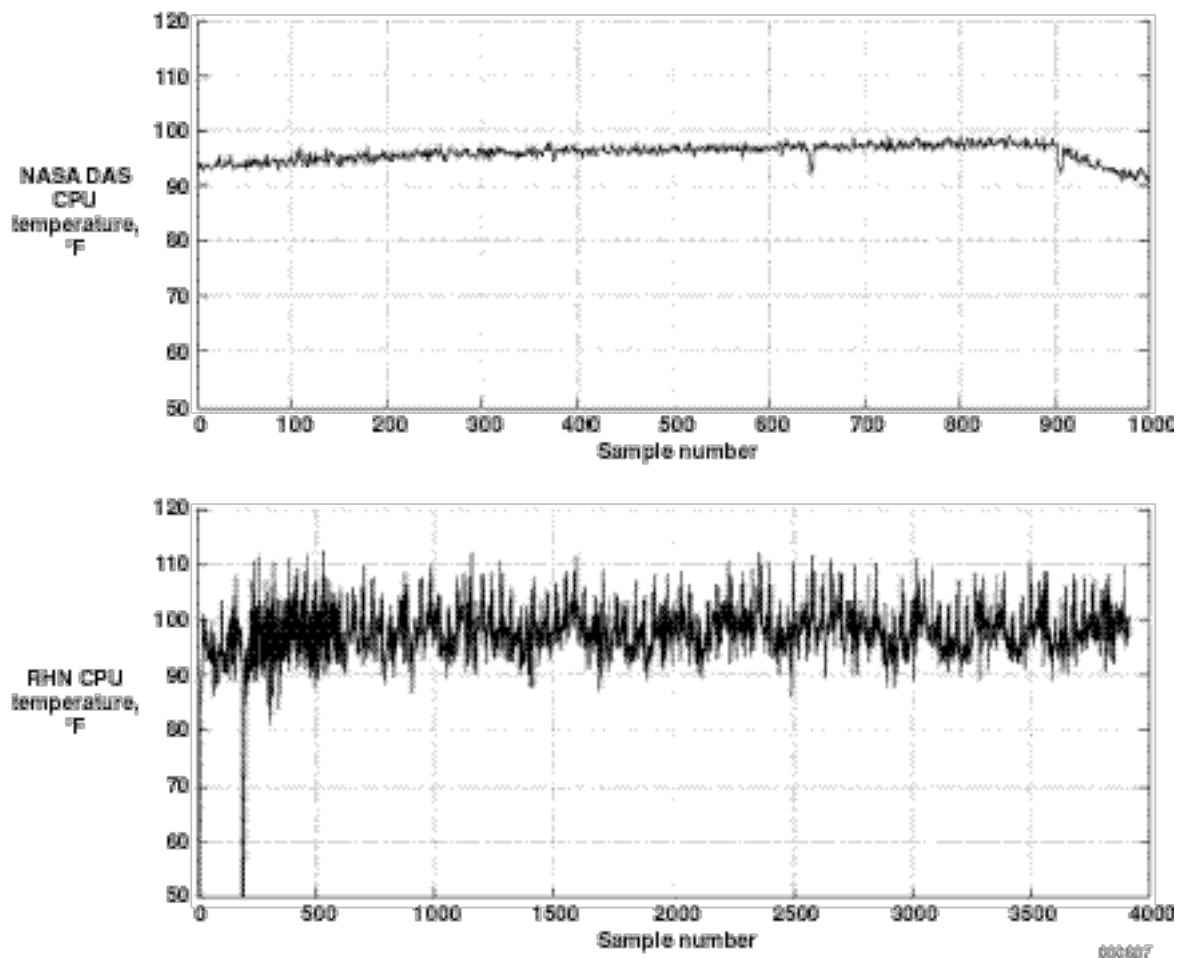
Figure 6. Flight data.

The RHNs performed without failure during the entire flight program. The data correlated well with the NASA DAS but exhibited higher levels of noise on the individual channels. Figure 6 shows elevated noise levels for colocated thermocouples recorded using the VHM System and the NASA DAS. RHN-B data were lost for the first 21 flights
